**CONNECTICUT RIVER BASIN  
SPRINGFIELD, MASSACHUSETTS**

**VAN HORN PARK LOWER DAM  
MA 00571**

**PHASE 1 INSPECTION REPORT  
NATIONAL DAM INSPECTION PROGRAM**

**JULY 1978**

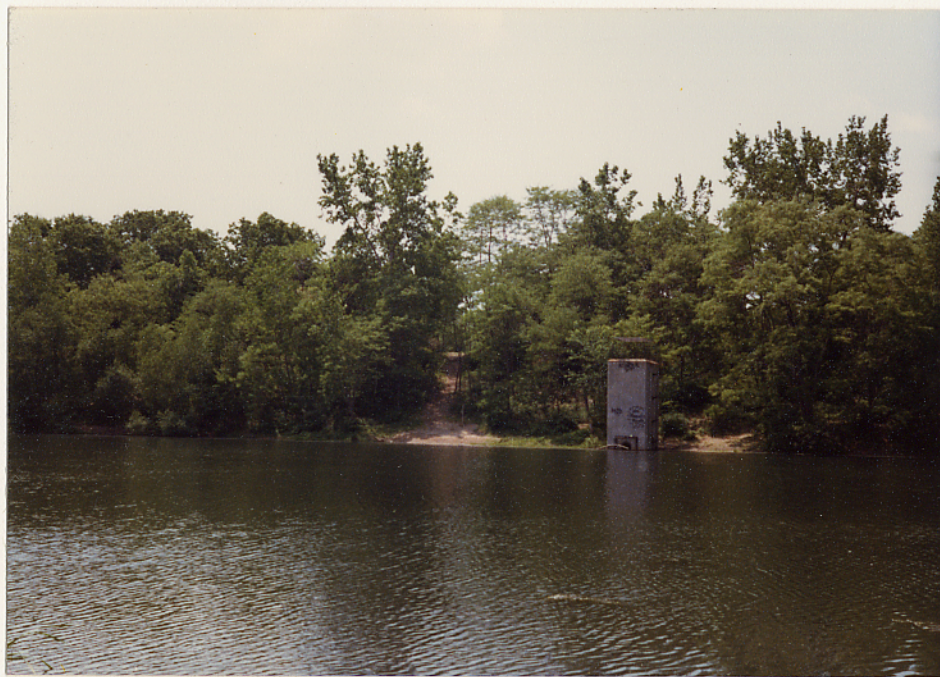
① GENERAL OVERVIEW OF UPSTREAM SLOPE OF DAM

Both slopes of the embankment are heavily overgrown with vegetation. There is evidence of erosion caused by trespassing; reportedly by trail bikes. The latter have caused severe rutting and depressions on the crest and along several transverse paths on both slopes. Except for these conditions, the vertical and horizontal alignment of the crest appears to be good. There is other minor erosion on the slopes, however, no sloughing or surface cracks were noticed because of heavy vegetation. It should be noted that one of the drawings prepared for the 1957 alterations, indicates a bench approximately mid-height of the downstream slope. During the inspection, no evidence of this bench was found. In addition the lower portion of the downstream slope appears to be substantially steeper, (approximately 1(V): 1 1/2 (H), than shown on the drawing.

g. Heavy bush, shrubs and young saplings should be removed from all locations on the embankment. Larger trees should not be removed but should be inventoried and their condition monitored. If a tree dies, the area around the tree should then be included in the inspection program for seepage.

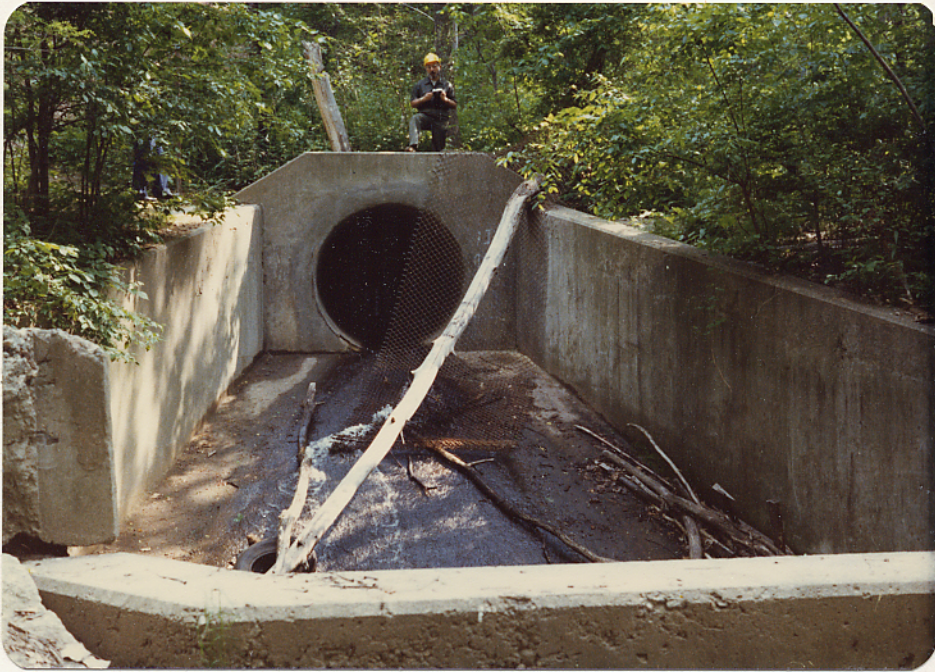
The stilling basin appears to be in fair condition with some minor spalling and erosion of concrete along the floor and walls. There is some algae growth on the wall directly below the brook inlet. Only two drain holes in the floor of the basin were visible and showed no evidence of functioning. The other drains were covered with large quantity of debris, some of which was quite large. This debris almost completely covered the upper end of the 48-inch diameter outlet pipe but did not appear to hinder low flow. (See Photograph). The riprap which surrounds the stilling basin was completely covered by soil and vegetation. At the lower end of the stilling basin the riprap has been displaced vertically about 3 feet.

② STILLING BASIN SHOWING 72" DIAMETER CONDUIT OUTLET

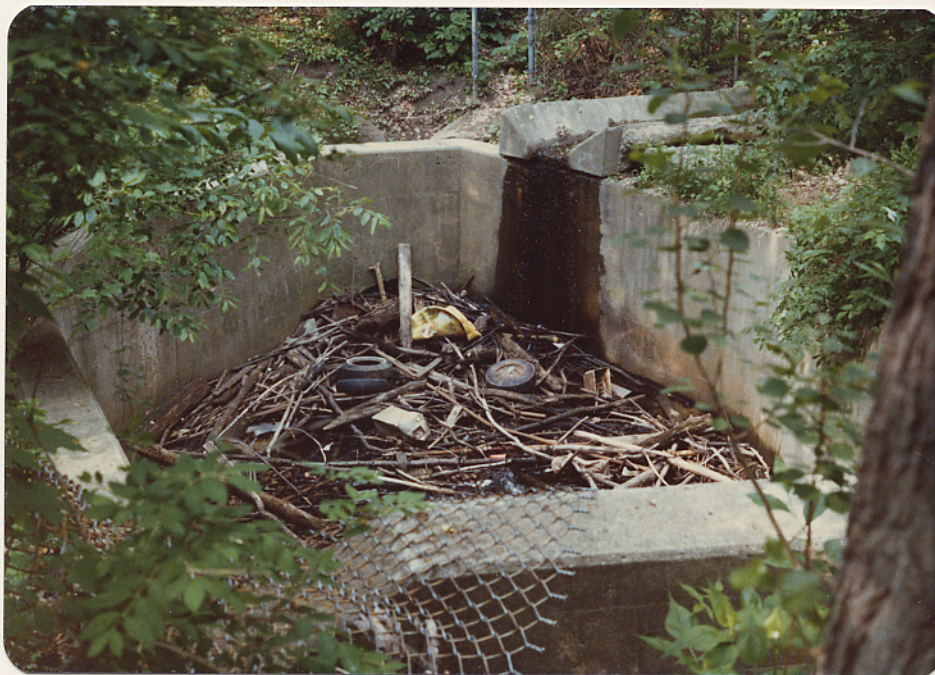
A wet area is located at a low point near the downstream toe, 100 feet south of the stilling basin. It was not possible to determine whether the wet area is caused by seepage or surface runoff which appears to collect at this point. On the north side of the basin, parallel to the downstream toe, is a brook which carries the water discharged through the low level outlet of the Van Horn Park Upper Pond. The brook flows in a natural bed along the toe, then a trapezoidal concrete channel, which empties into the stilling basin. (See photograph).

③ STILLING BASIN, SHOWING 48" DIAMETER OUTLET  
CONDUIT BLOCKED BY DEBRIS AND BROOK DRAIN TROUGH

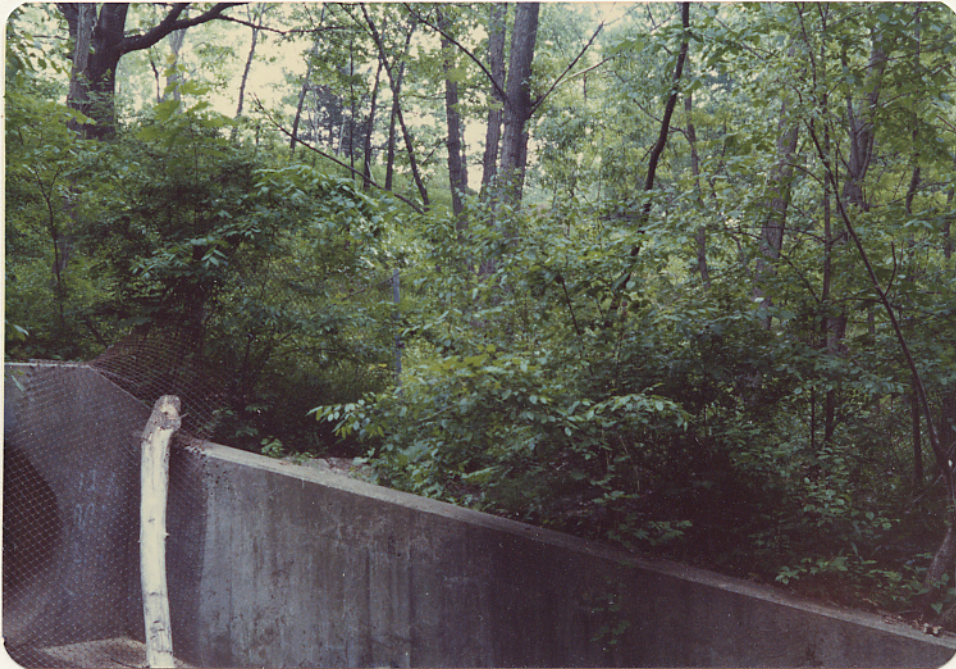
④ DOWNSTREAM SLOPE LOOKING SOUTH SHOWING EXTENSIVE VEGETATION

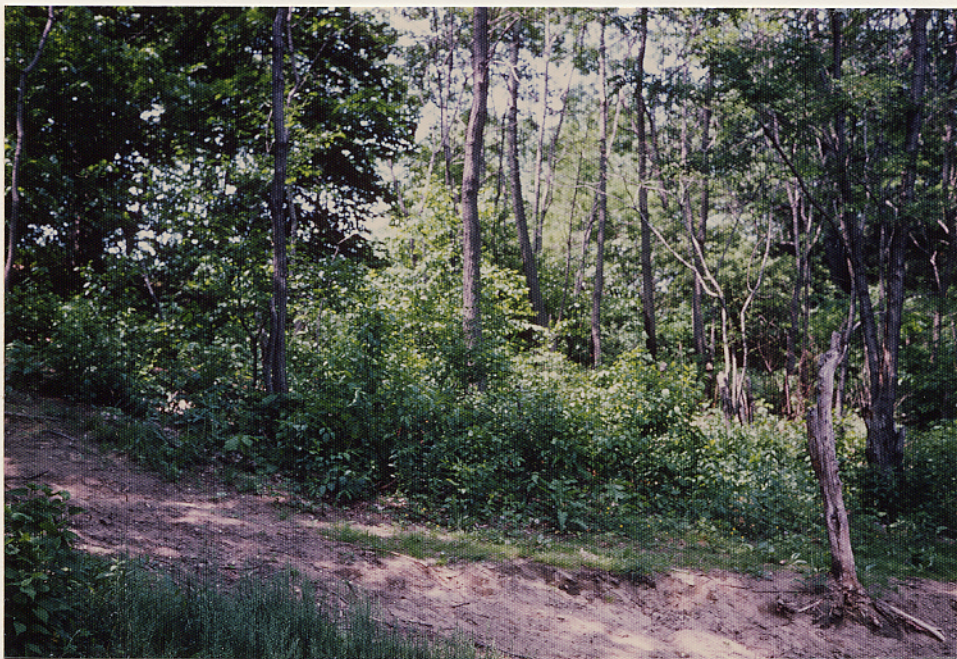
Trespassing on Slopes Bikes trails and paths have caused depressions and ruts

⑤ DOWNSTREAM SLOPE LOOKING NORTH SHOWING  
EXTENSIVE VEGETATION AND RUTTING

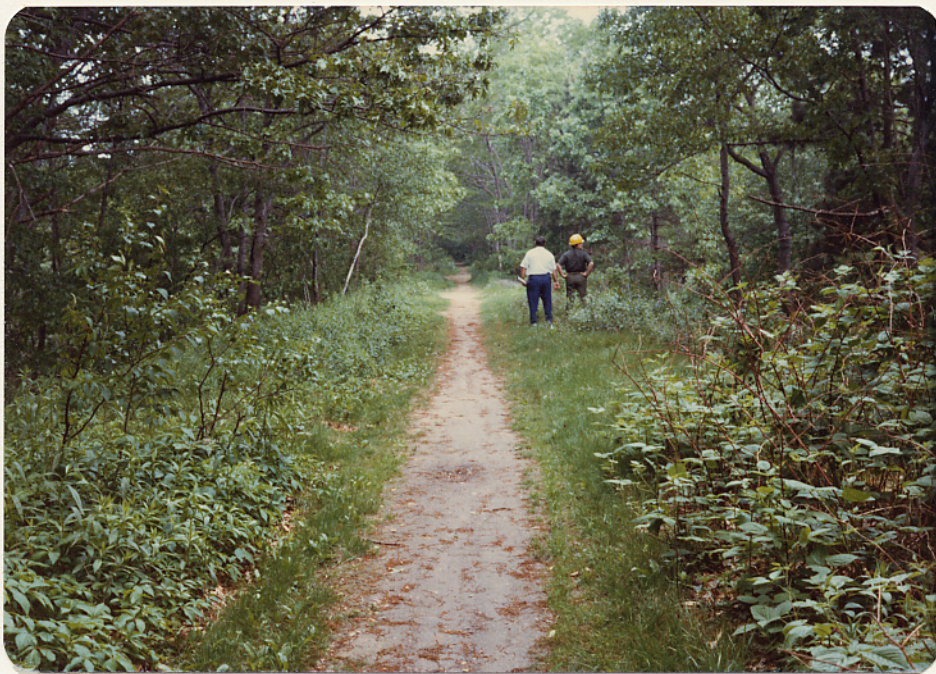
Movement or Settlement of Crest None except for some ruts and other depressions caused by bike traffic

⑥ VIEW OF CREST SHOWING BIKE TRAIL AND EXTENSIVE VEGETATION

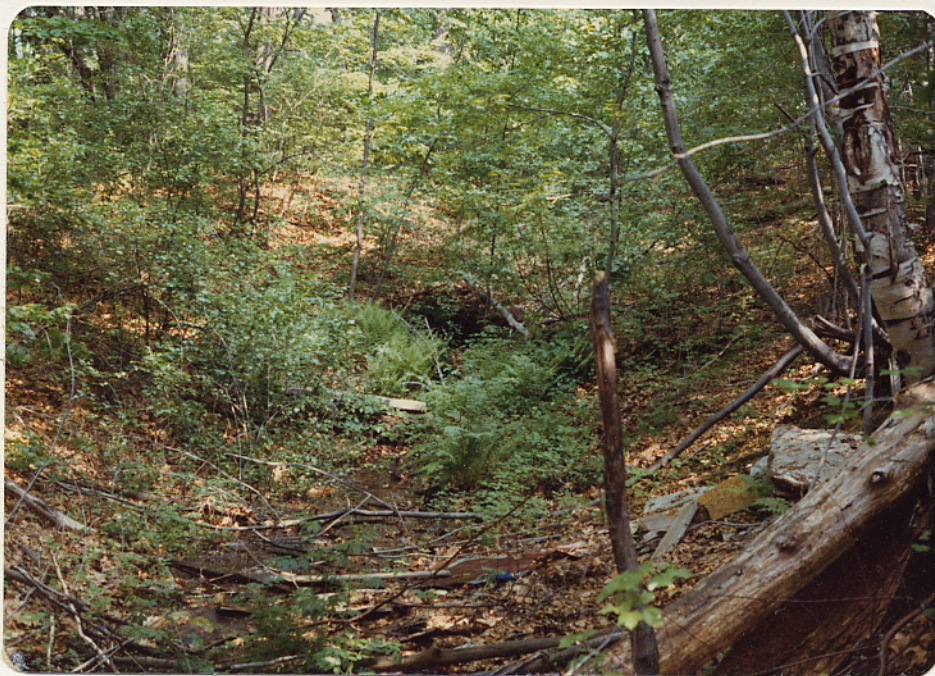
⑦ DOWNSTREAM TOE SHOWING BROOK AND LOW LEVEL  
OUTLET OF VAN HORN PARK UPPER DAM
